Operation TEAPOT

Project 31.2

DAMAGE TO COMMERCIAL AND INDUSTRIAL BUILDINGS
EXPOSED TO NUCLEAR EFFECTS

Bruce G. Johnston

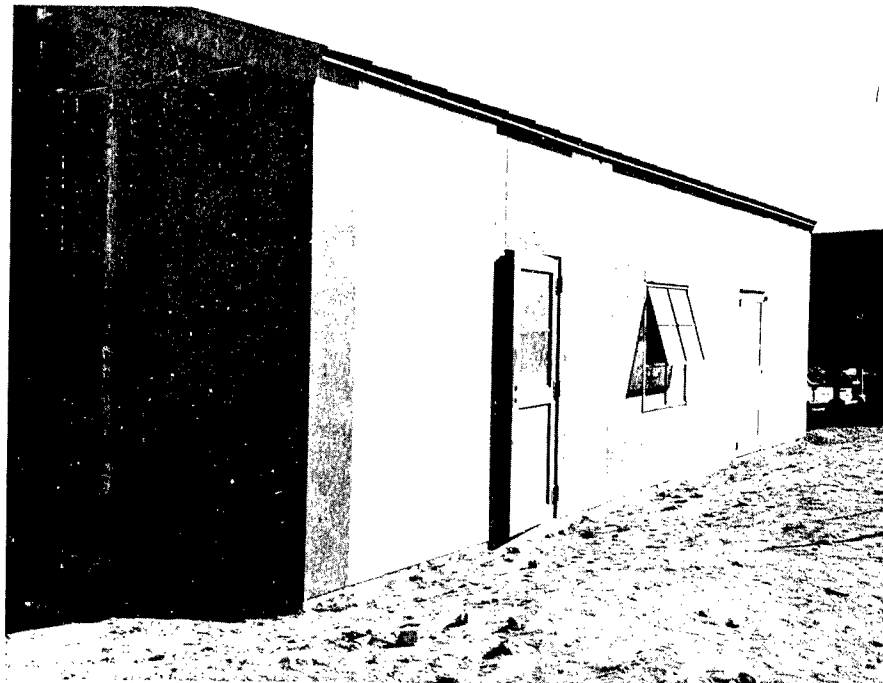
Fig. 1.22—Armco Building 31.2-d1 repaired after unexpected test.

after repair of the north wall damage, was previously illustrated in Fig. 1.22. Appendix B provides an analysis of the dynamic behavior of Building 31.2-d1.

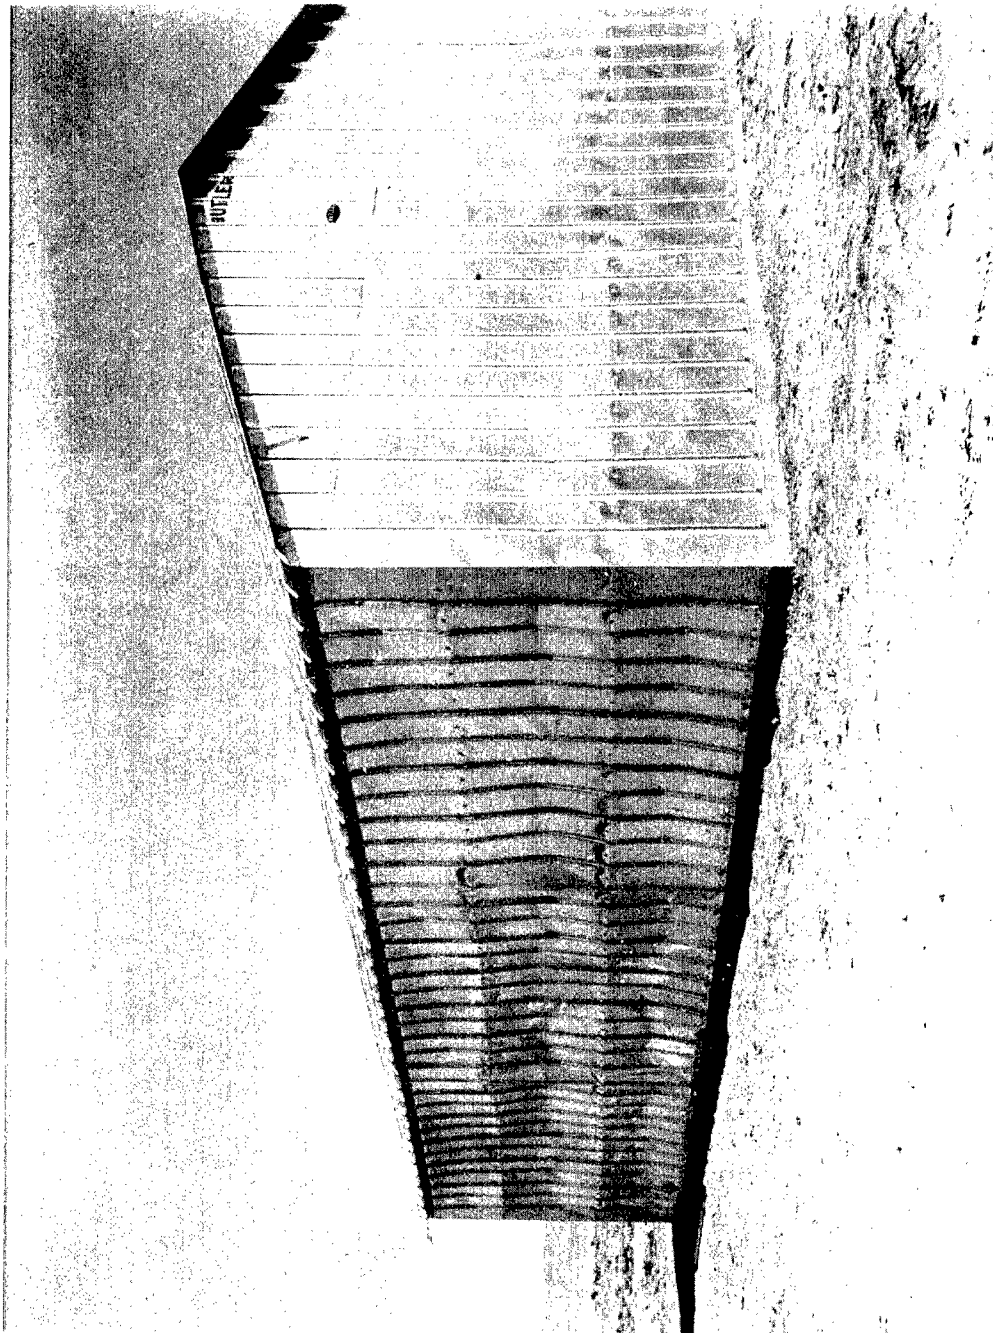
Figure 2.1 gives a general indication of the damage from the unexpected test to the north wall of Reynolds-Butler Building 31.2-a1, which was left with permanent inward deflections up to 5 in. The offset measurements, as recorded at the site, are tabulated in Fig. 2.2 for both the unexpected and planned tests. The two wall girts were bent in along with the paneling, and the bolt heads of the panel fasteners were generally pulled through the sheeting. Washers had been omitted along these two lines of bolts, and hence no definite conclusion can be made as to the probable extent of pull through if they had been included. The roof sheeting was left with downward permanent sets, especially in the span immediately adjacent to the eaves, where the permanent deflections, as shown in Fig. 2.3 and recorded in Fig. 2.2, were measured up to 3 in. The roof purlins were not deformed appreciably. The interior view of the wall (Fig. 2.4) shows how twisting of the girts occurred with measured values up to 43°. It is also of interest to note the imprint of the wind-bracing ties on the wall paneling, indicative of the initial deflections that were experienced. A dynamic analysis of wall behavior in both the unexpected and planned tests is provided in Appendix A.

As shown in Fig. 2.1, the panels on the west end of the building suffered very little permanent deformation. The unexpected test involved a moderate northeast exposure, and at the east end, as indicated in Fig. 2.5, the panels were bent inward to a degree comparable with those on the north side. This picture was made during the process of repair, with damaged north and south wall panels removed but with the bent and twisted wall girts still in position.

Fig. 2.1 — General view of north and west end walls, showing damage from unexpected test to Reynolds-Butler Building 31.2-a1.

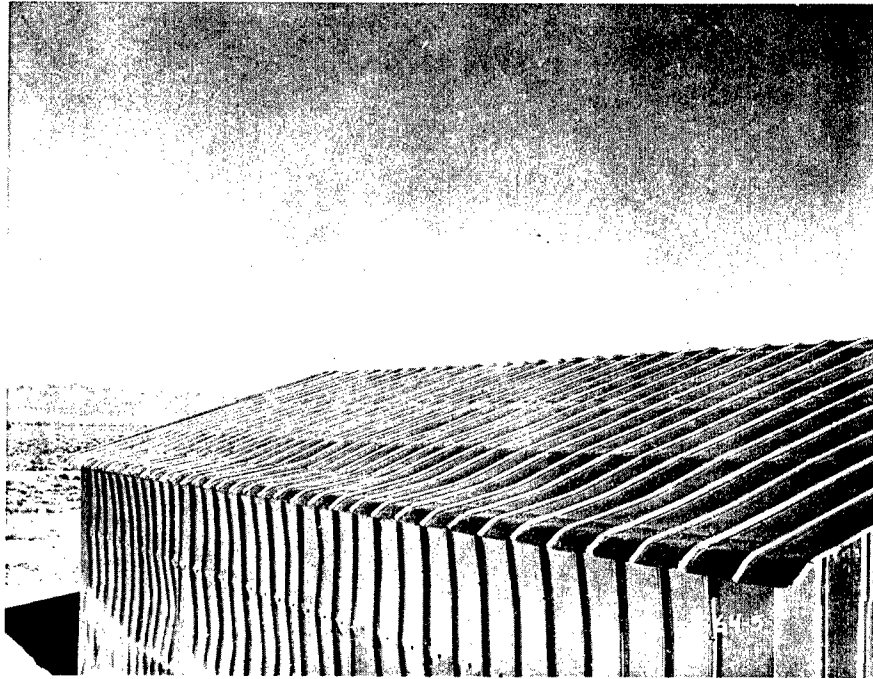
Fig. 2.3 — Damage to roof of Reynolds-Butler Building 31.2-a1 from unexpected test.

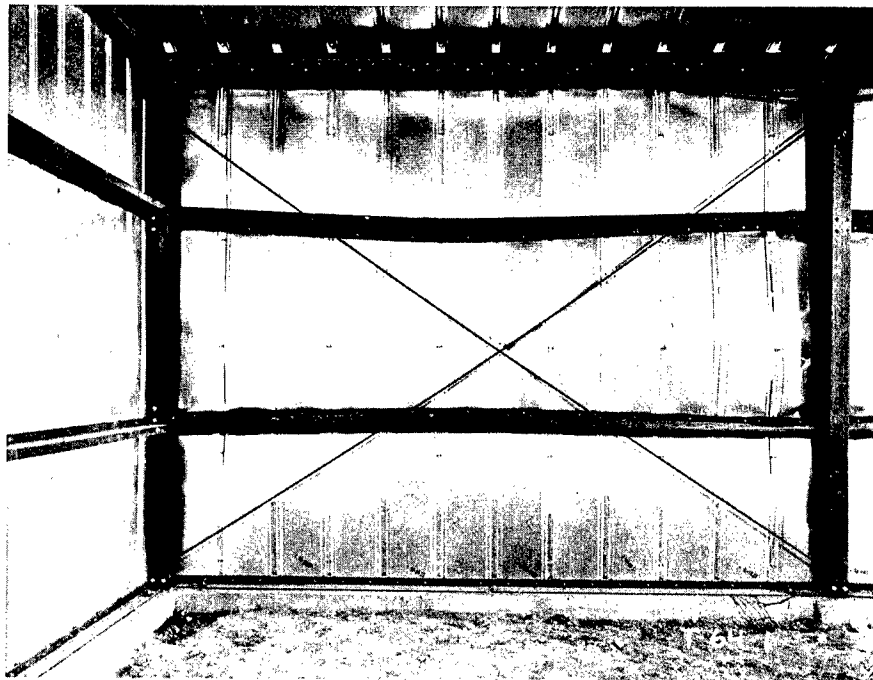
Fig. 2.4 — Interior view of damage to north wall in Reynolds-Butler Building 31.2-a1 from unexpected test.

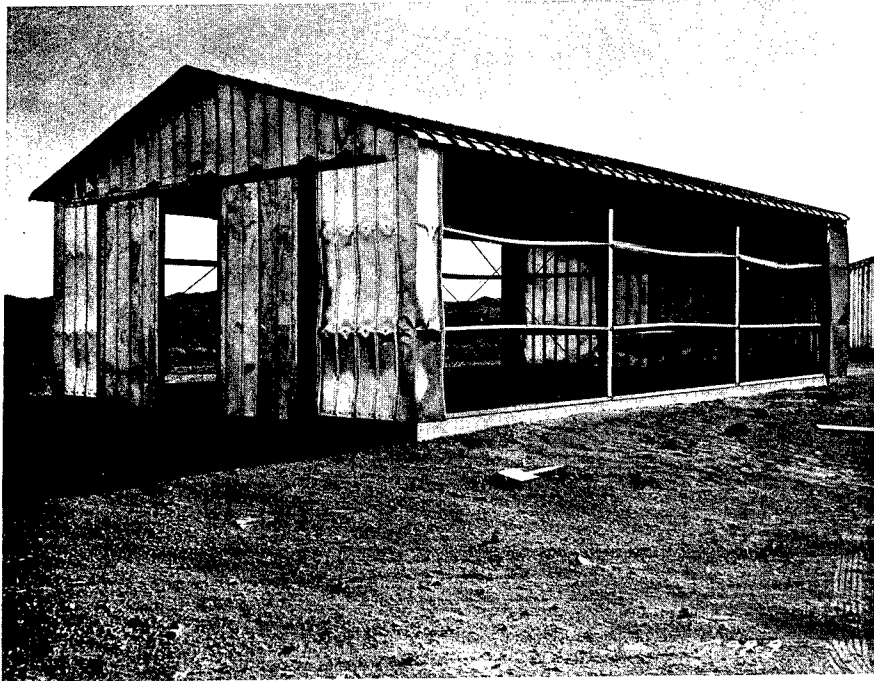
Fig. 2.5—North and south sides of Reynolds-Butler Building 31.2-a1 during repair of damage from unexpected test.

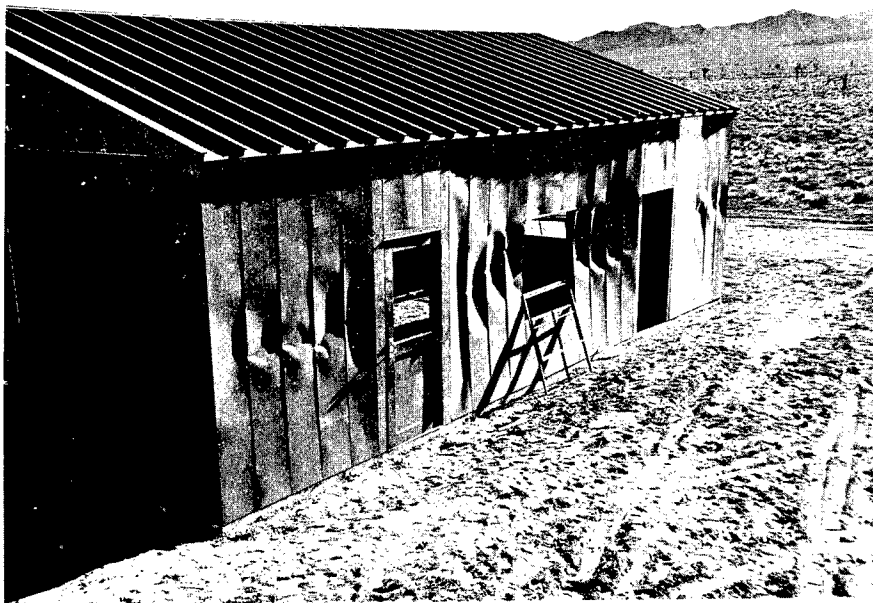
Fig. 2.6—Damage to north walls of Armco Building 31.2-d1 from unexpected test.

Permanent deflections along the north side of Armco Building 31.2-d1 are shown in Fig. 2.6 and are recorded in Fig. 2.7. The first five wall panels on the east and nearest the blast origin were damaged to a lesser extent. Maximum permanent deflections of the north wall, amounting to 4.8 in., were measured adjacent to the north window. Figure 2.8 shows the local buckling on the inside of the north wall near the location of maximum deflection. This building,

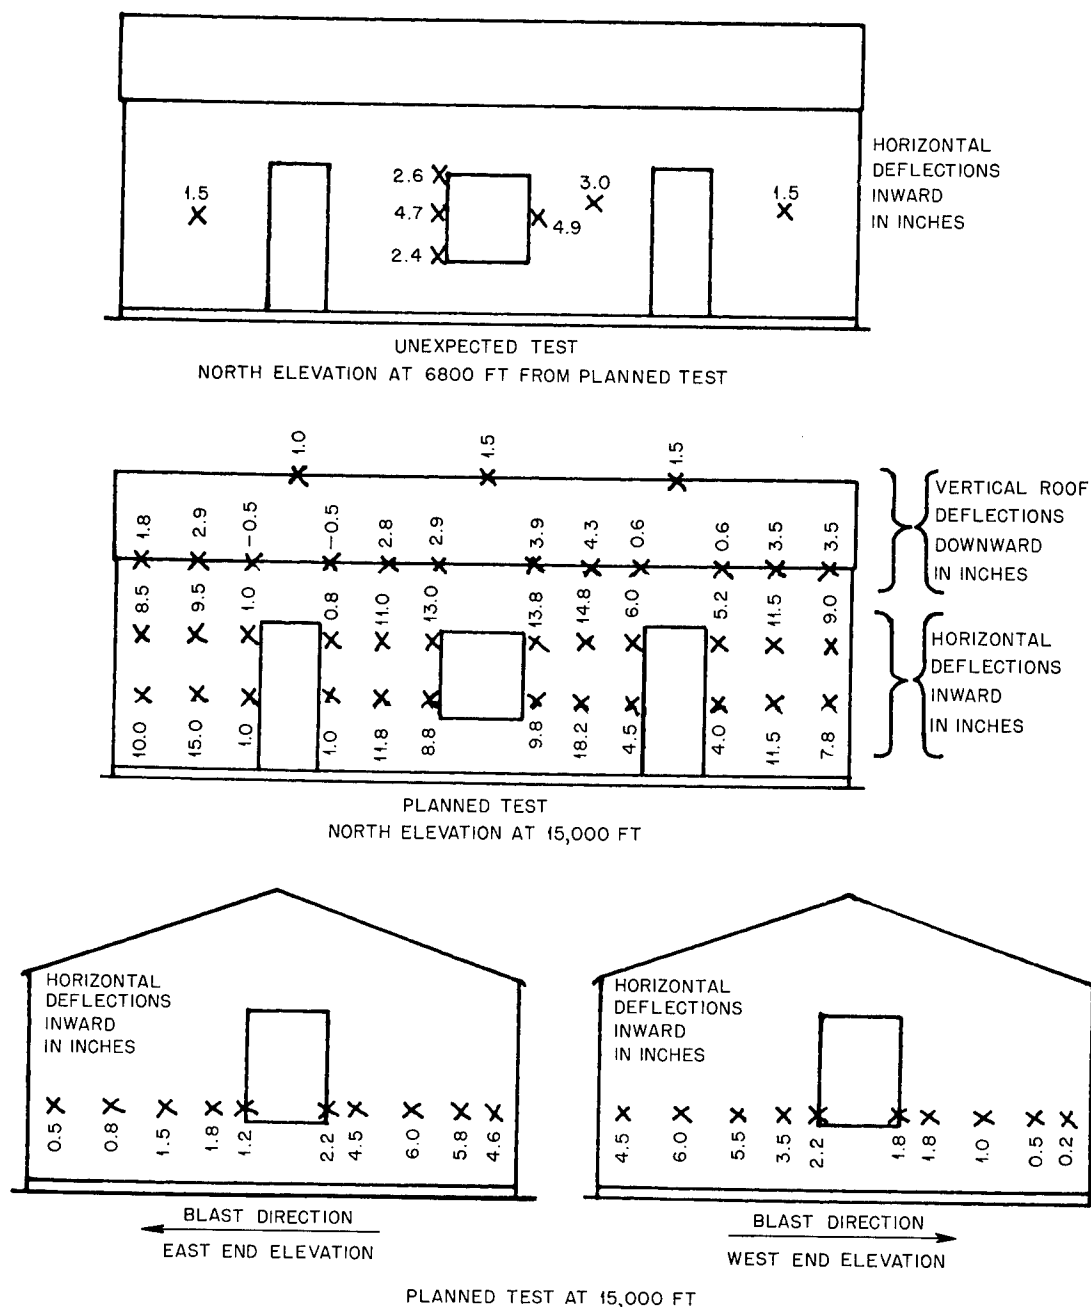
Fig. 2.7—Offset measurements of permanent wall and roof deflections in inches in Armco buildings that remained intact.

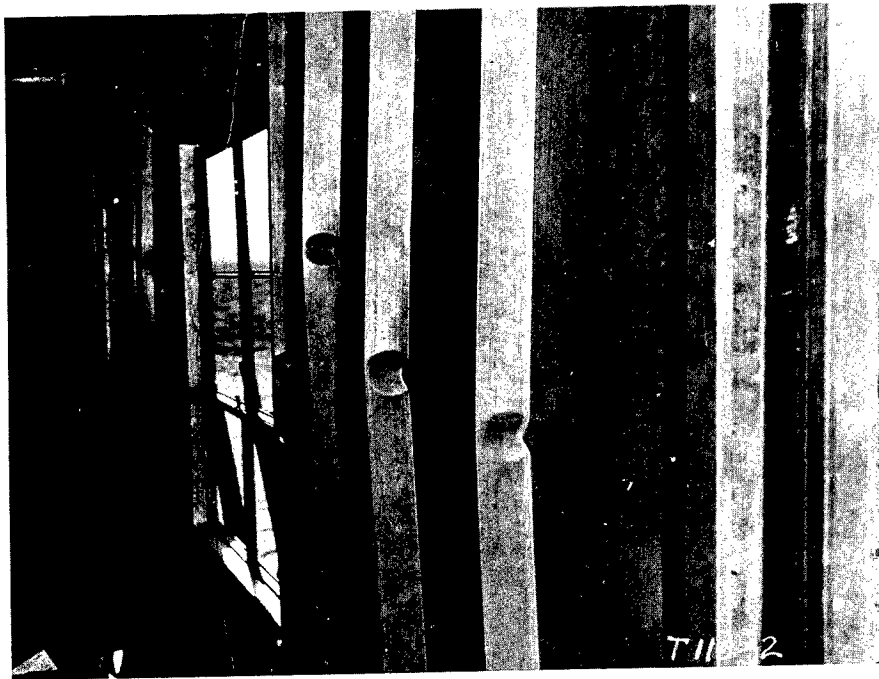
Fig. 2.8 — Interior view of damage to north wall of Armco Building 31.2-d1 from unexpected test.

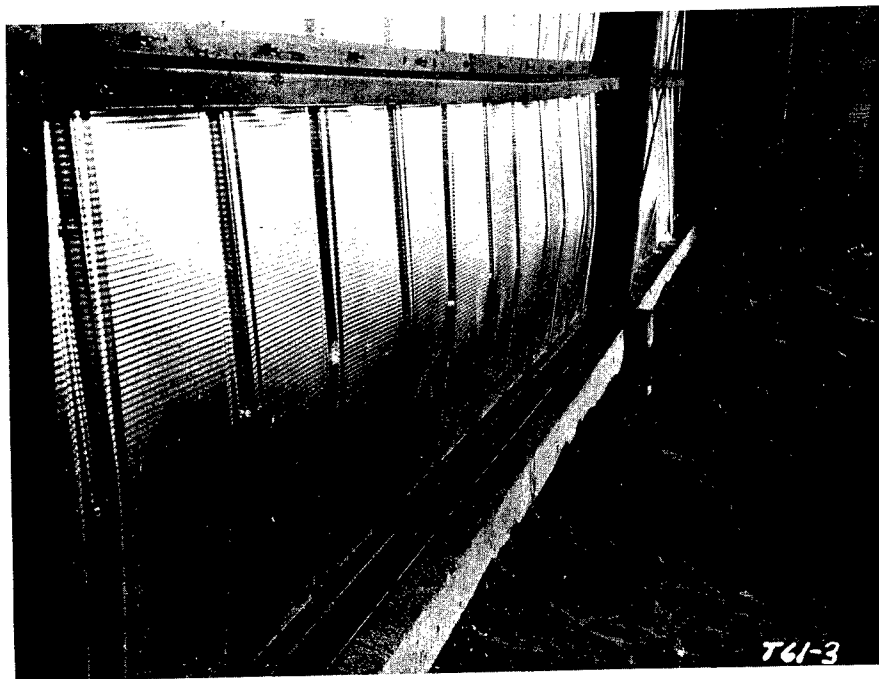
Fig. 2.9 — Interior view of wall damage in Reynolds-Butler Building 31.2-a2 from unexpected test.

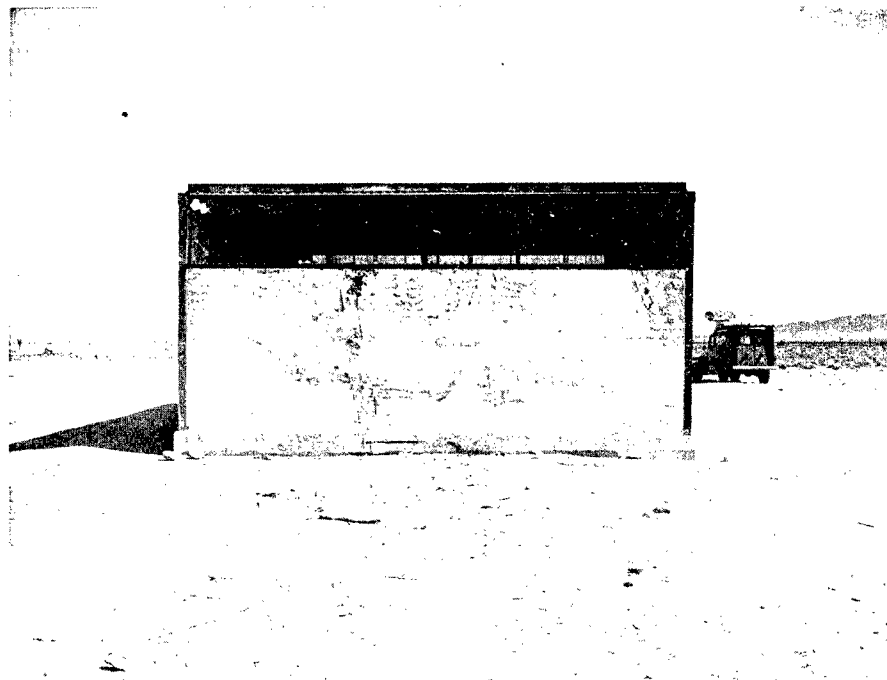
The trajectory of the window pieces from the north wall appeared to be downward. Although there were indications that small particles had struck the south wall window, most

Fig. 2.10—North wall of Union Carbide building after planned test.

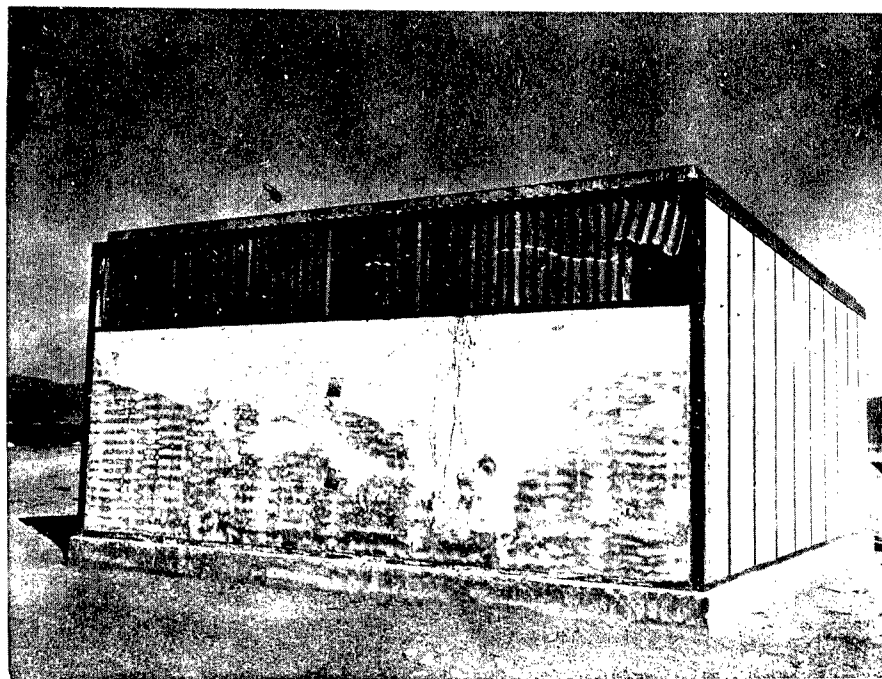
Fig. 2.11—South wall of Union Carbide building after planned test.

marks were made on the gypsum portion of the south wall. The portion of the south window that was broken outward could have been damaged by a piece of the north window. The marks left by the plastic pieces were not sharp and penetrating.

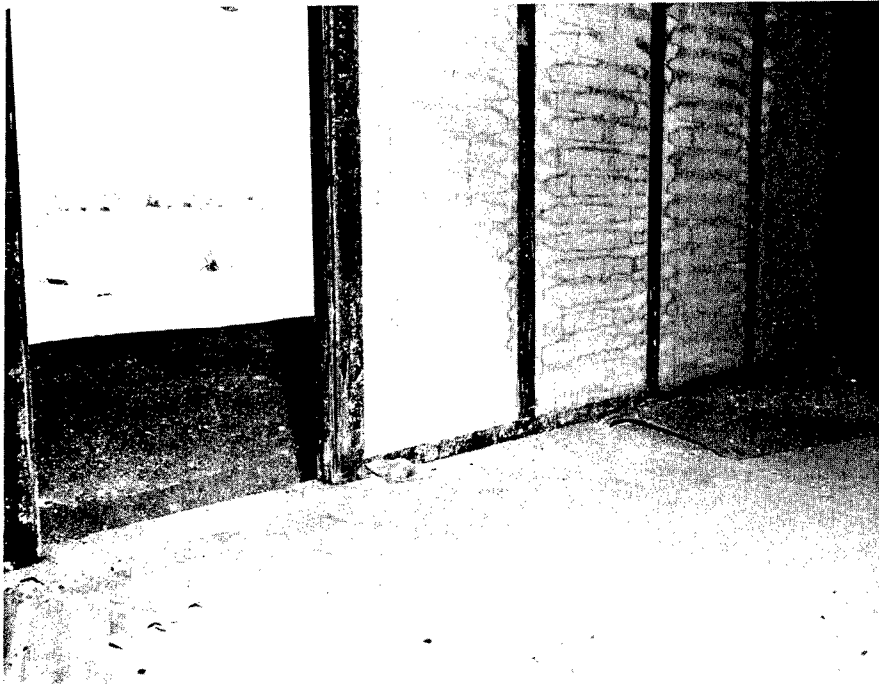
Fig. 2.12—Interior view looking out doorway of Union Carbide building after planned test.

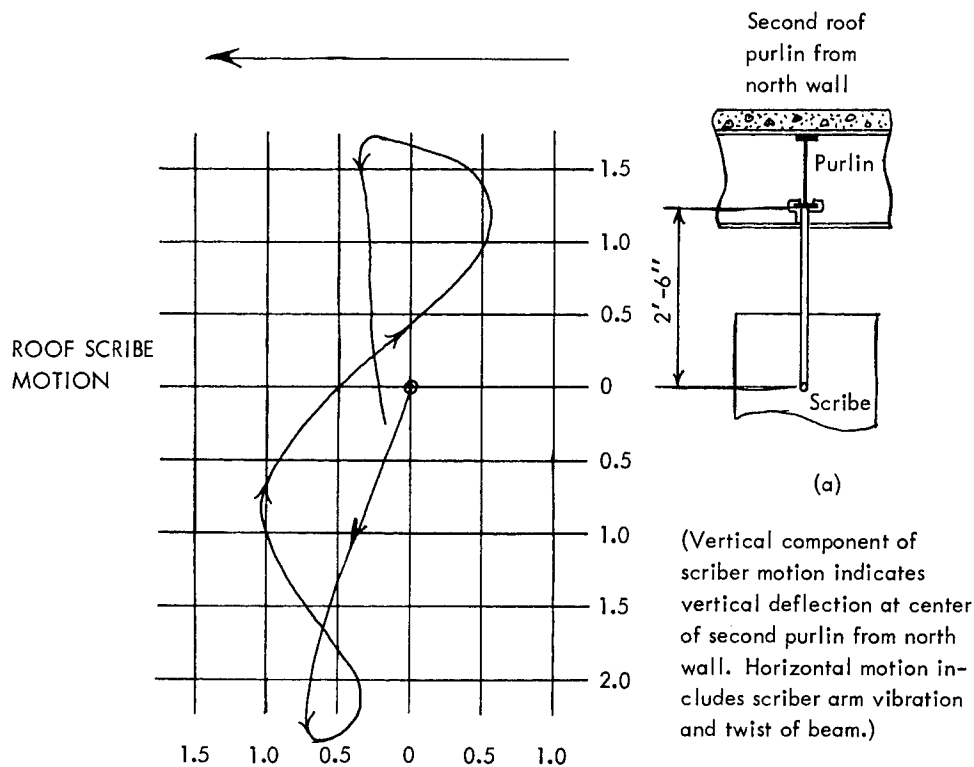
Fig. 2.14—Deflections of roof and north wall in Union Carbide building during planned test.

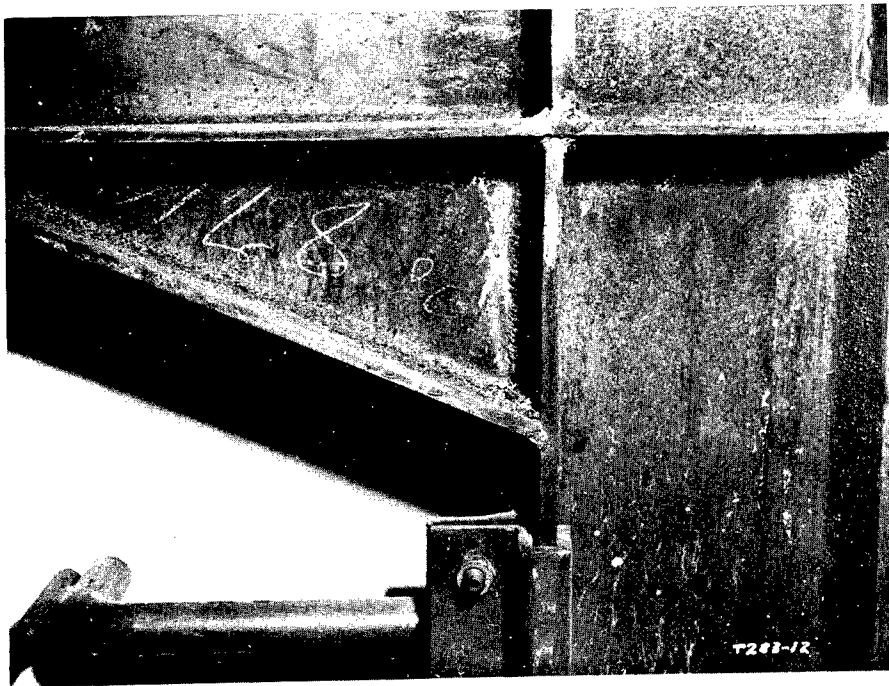
Fig. 2.15—Southeast corner frame connection of Union Carbide building.

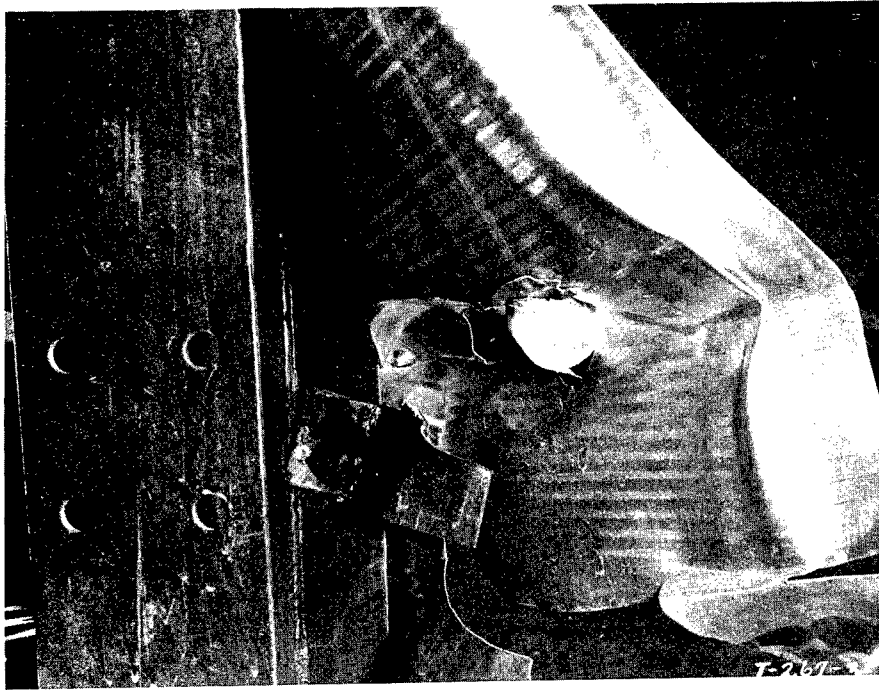
Fig. 2.21 — Interior detail of torn girt connector north of Reynolds-Butler Building 31.2-a1 after planned test.

Figure 2.21 shows the detail of a torn girt connector which is typical of the end failures of this member. Approximately one-half of the total girt area is cut away at this point to provide sufficient coping of the Z bar in order to eliminate interference between the exterior panel and the front face of the columns. The girt is then attached by a single $\frac{1}{2}$ -in.-diameter bolt passing through a slotted hole. Initially, the slotted hole permits a longitudinal movement of the girt which is resisted only by the friction between the bolt and the girt material. Then at the sharp internal cut, the girt starts to tear at the end. As it does so, the torn piece of girt that remains attached to the column is twisted almost 90° , as shown in Fig. 2.21. There is some information available on the strength of eccentrically loaded tension members of steel which fail by tearing that starts at one side, due to a notch or stress concentration, and information¹ is also available on the strength of bolts in shear. The fact that the bolts did not fail

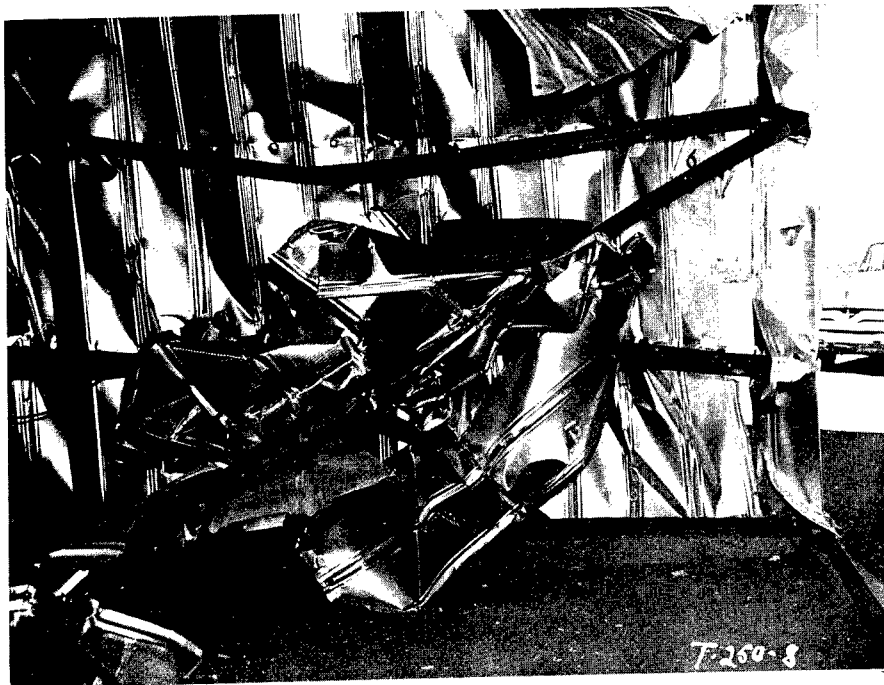
Fig. 2.22 — Interior view of Reynolds-Butler Building 31.2-a1 after planned test. (Note that west girts and panels of north wall have been thrown against west end.)

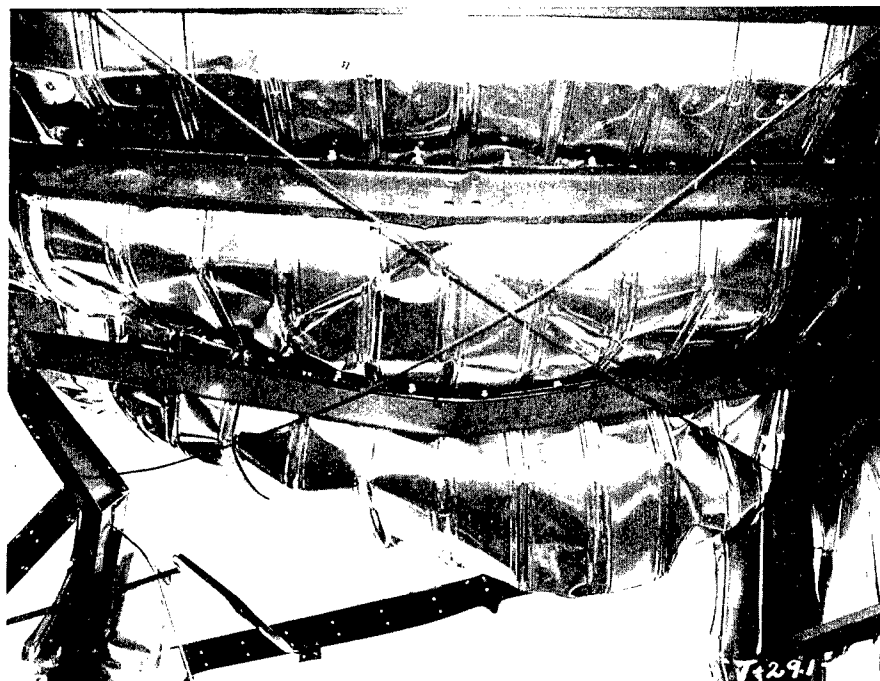
Fig. 2.23 —Roof purlins at northeast corner of Reynolds-Butler Building 31.2-a1 after planned test.

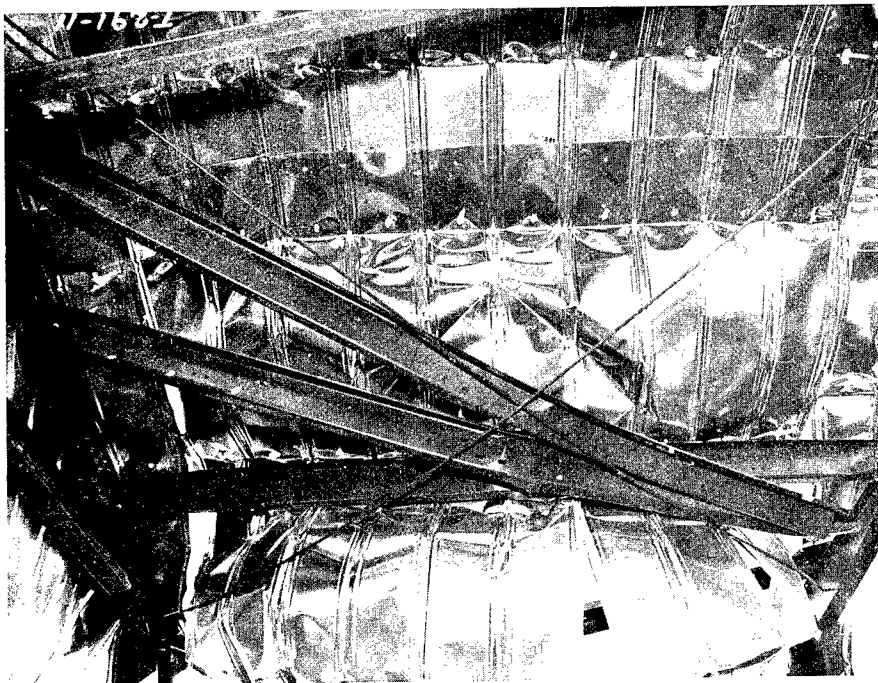
Fig. 2.25—Underside of roof at northwest corner of Reynolds-Butler Building 31.2-a1 after planned test.

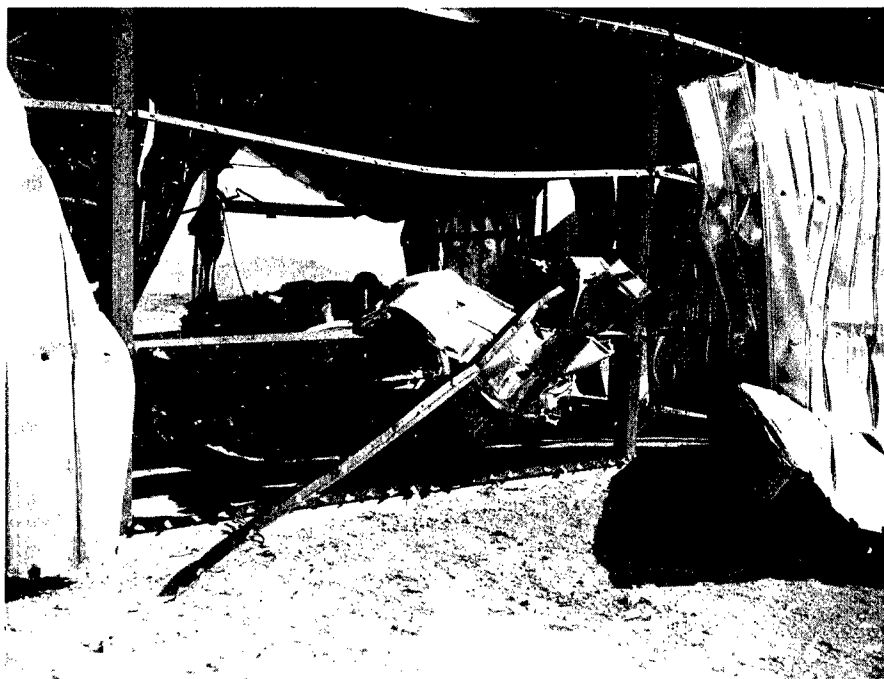
Fig. 2.27—North girts and siding blown through south wall of Reynolds-Butler Building 31.2-a1 after planned test.

shown in Fig. 2.27. They survived the experience of having the central wall girts and sheeting from the north wall blown against them after striking machinery within the building. Except along the ridge, the roof sheeting was largely detached from the purlins. The purlins on the south face of the roof were the least damaged of any sheet-supporting members, as shown in Fig. 2.28, a view looking upward at the east space of the south roof face.

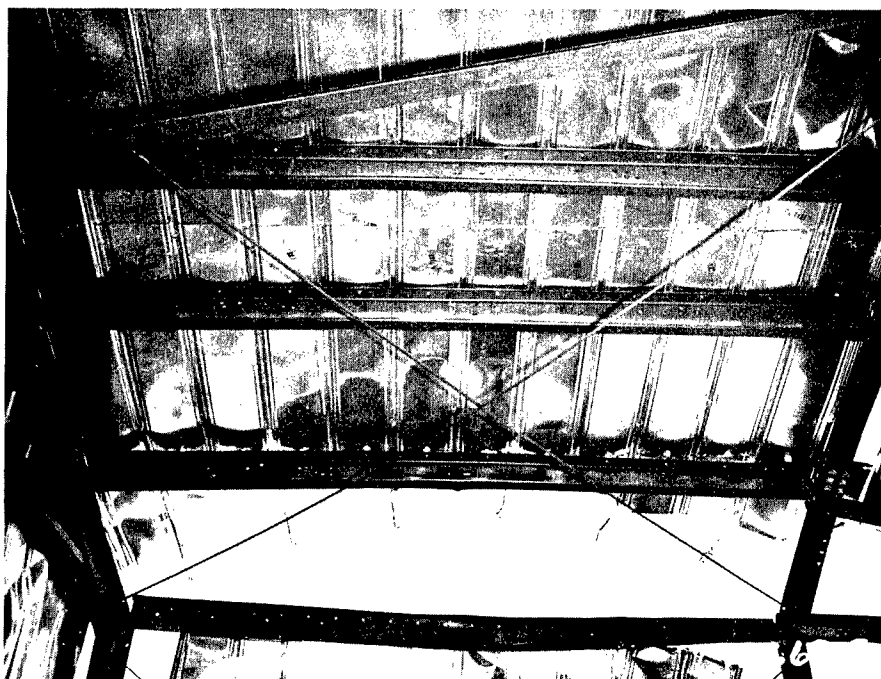
Fig. 2.28—Underside of southeast roof section of Reynolds-Butler Building 31.2-a1 after planned test.

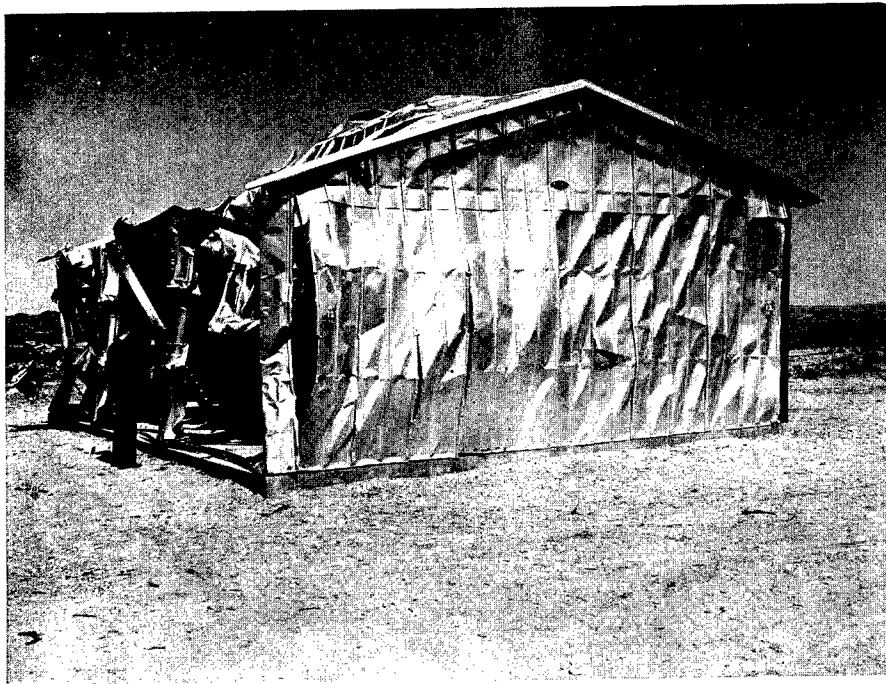
Fig. 2.29 — West end of Reynolds-Butler Building 31.2-a1 after planned test.

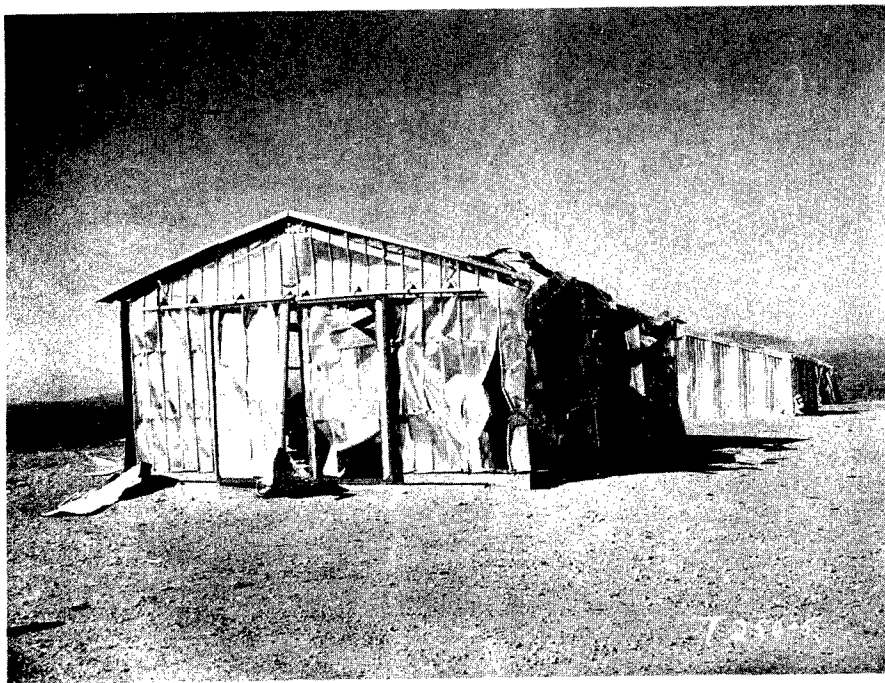
Fig. 2.30 — East end of Reynolds-Butler Building 31.2-a1 after planned test.

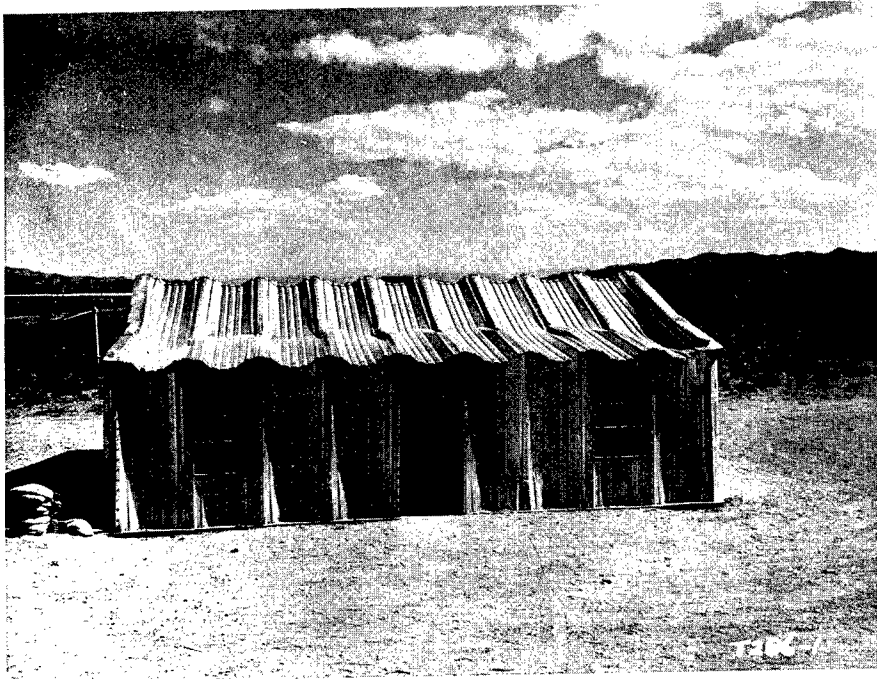
This building, at 6800 ft, was practically destroyed; the roof collapsed and rested at the center on machinery within the building. Front wall segments were wrapped around the machinery, and this provided a block that at least partially prevented additional movement of building wreckage in the downblast direction.

Fig. 2.31 —North side of Behlen Building 31.2-b1 after planned test.

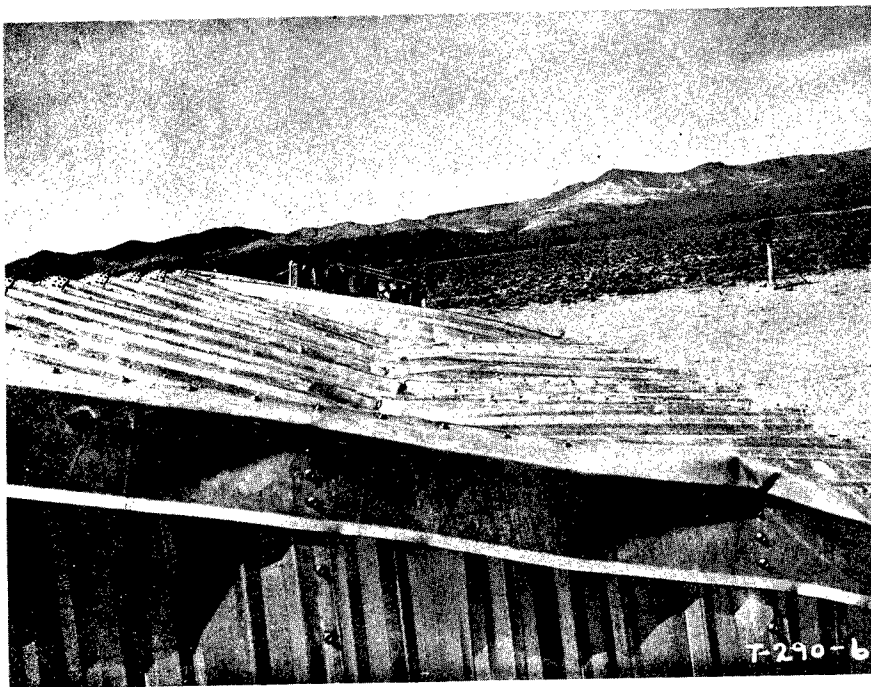
Fig. 2.32 —View looking along north roof of Behlen Building 31.2-b1 after planned test.

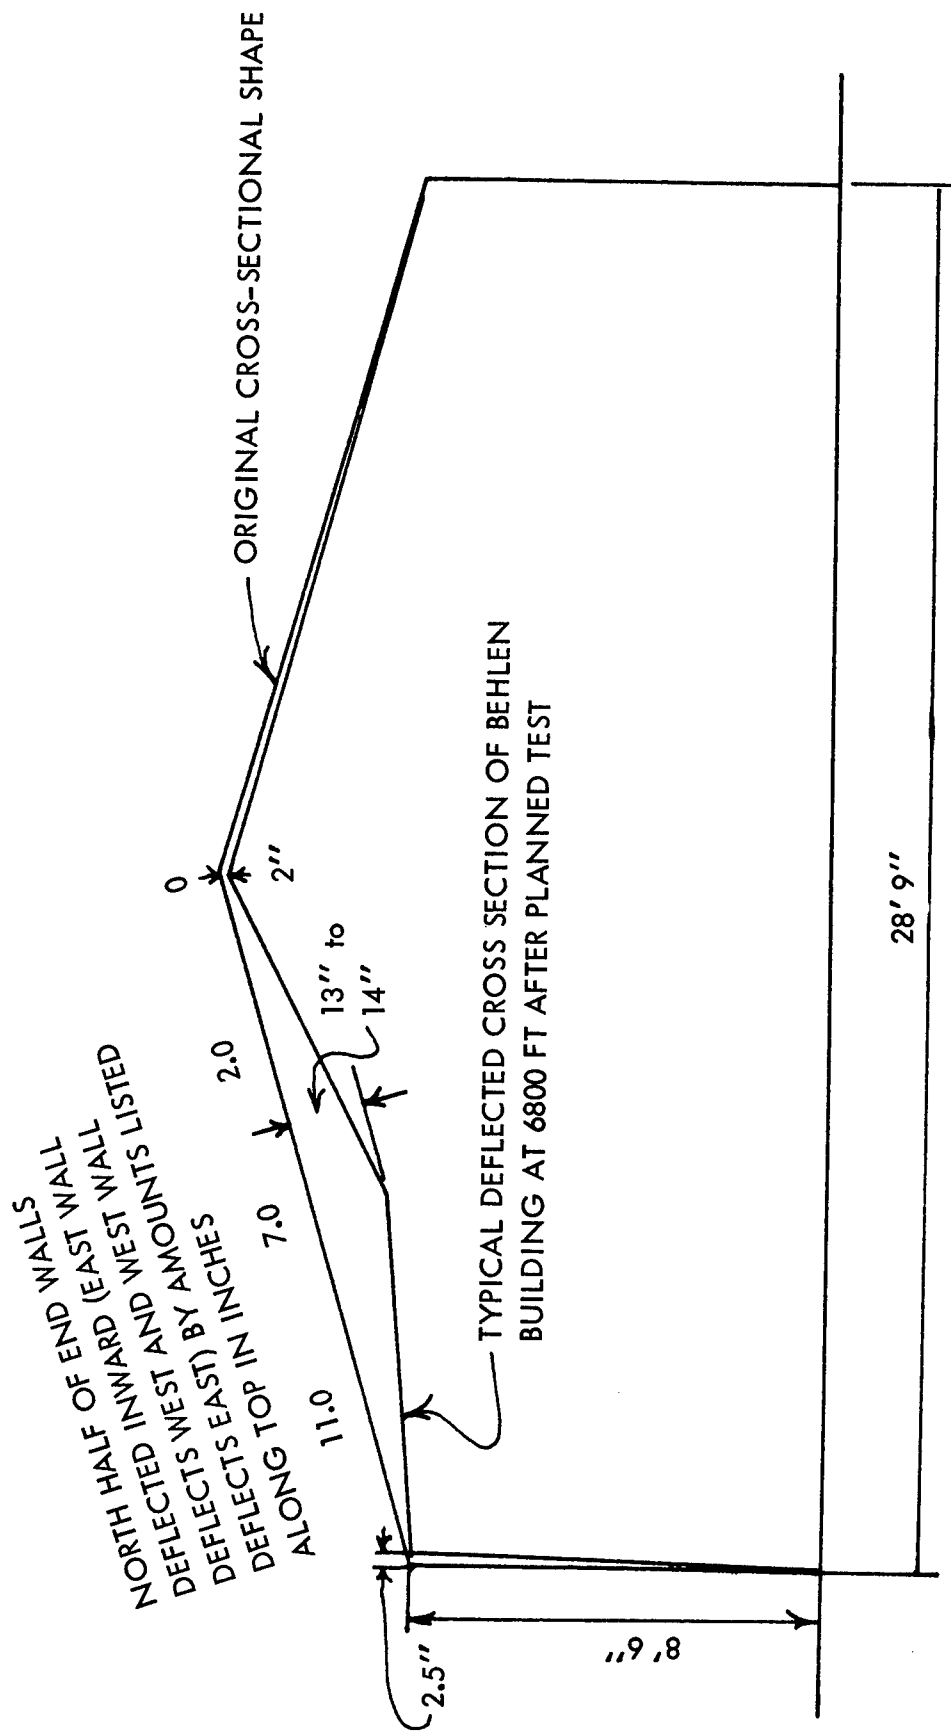
Fig. 2.33 — Permanent deflection of Behlen Building 31.2-b1 at 6800 ft after planned test.

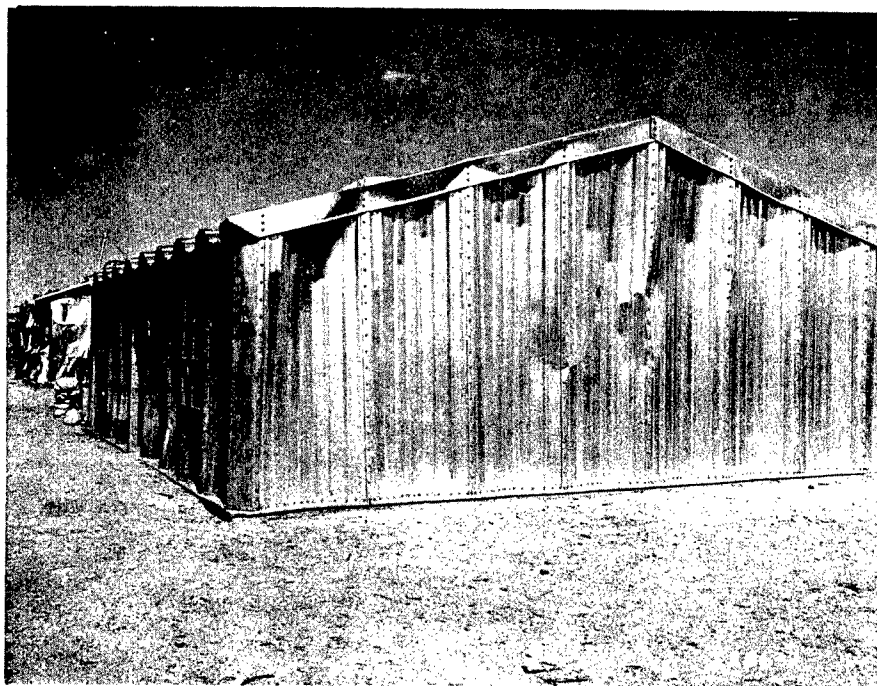
Fig. 2.34—West end of Behlen Building 31.2-b1 after planned test.

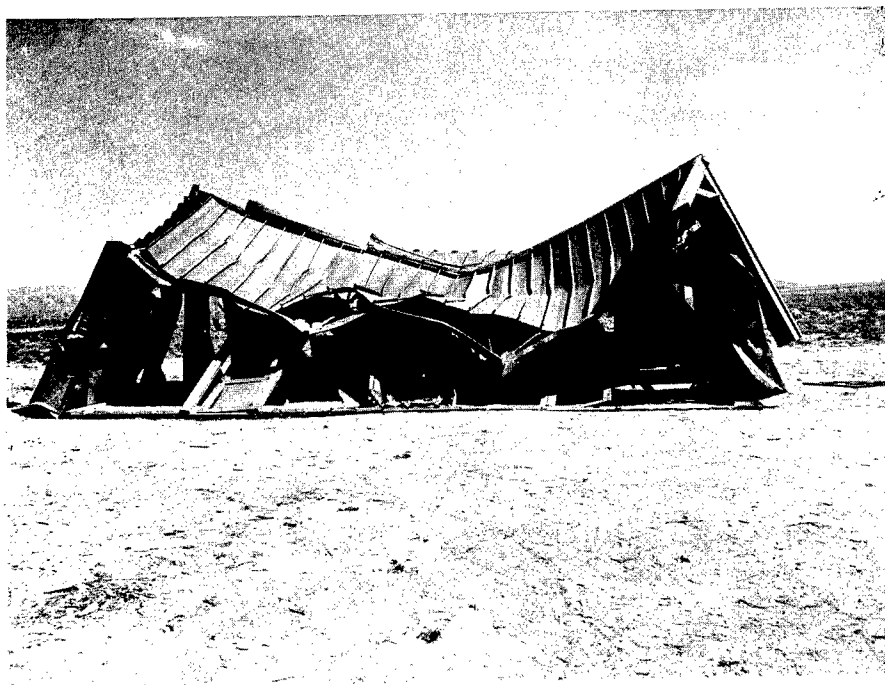
The north side of the building is shown in Fig. 2.37, which also indicates the sag in the roof. Figures 2.38 to 2.41 show various views of the crumpled ends and the south side of the building. Most of the wall segments remained on site, although the wall panels along the north side were largely torn loose from the wall sill connections, as shown in detail in Fig. 2.42, and one piece swept downblast about 50 ft. At the southwest corner of the building, the sill was also torn loose, as shown in Fig. 2.43. The wall paneling remained attached to the sill along 75 per cent of the east end and all the west end.

Fig. 2.37—North side of Armco Building 31.2-d1 after planned test.

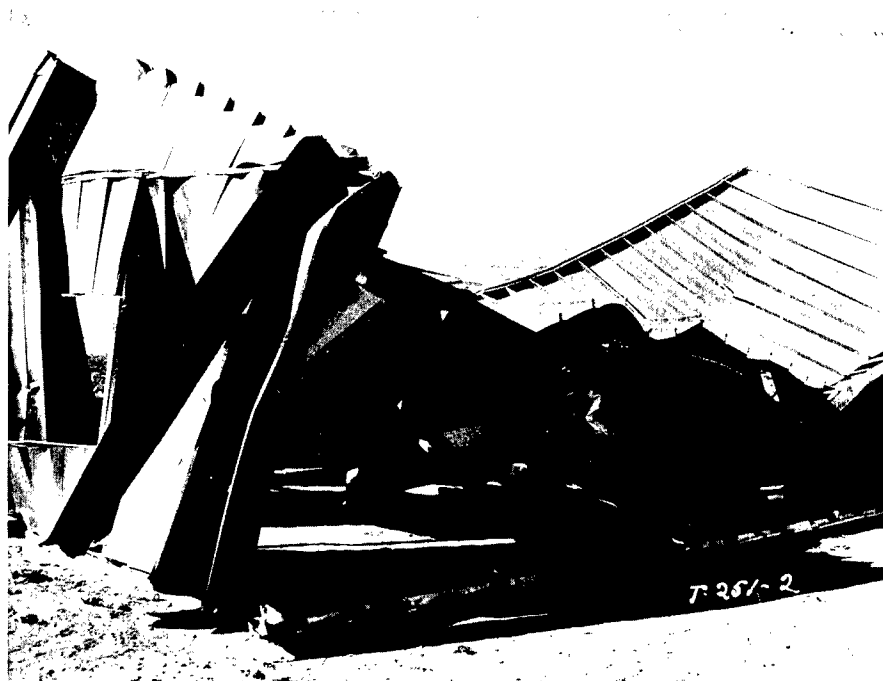
Fig. 2.39 — Northeast corner of Armco Building 31.2-d1 after planned test.

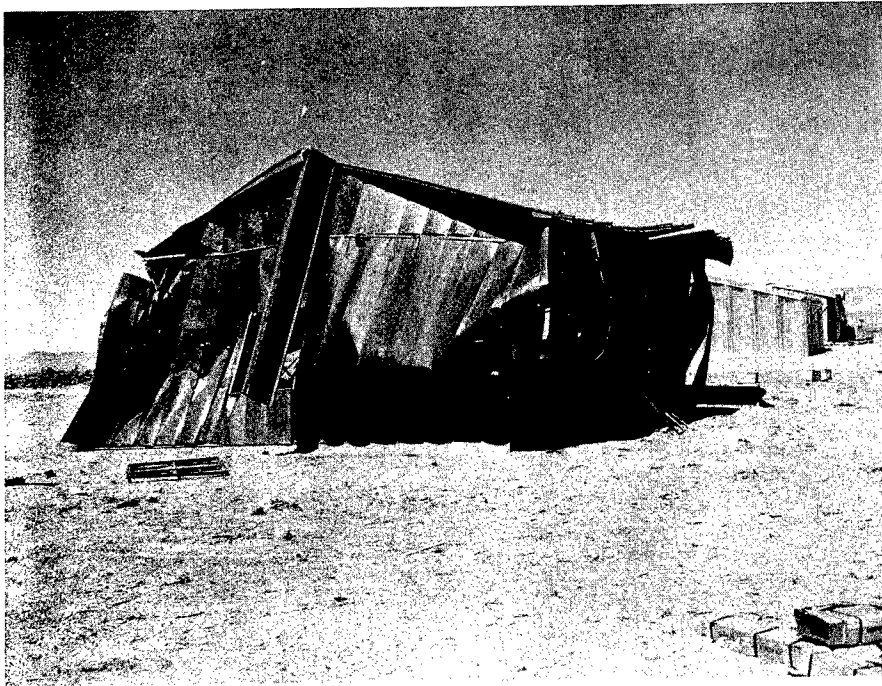
Fig. 2.40 — West end and south side of Armco Building 31.2-d1 after planned test.

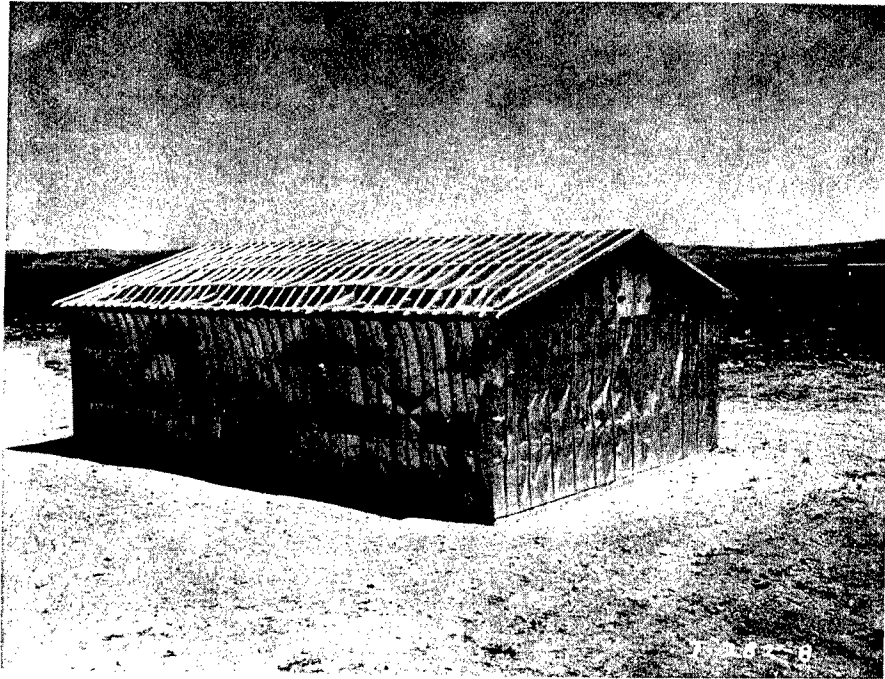
Fig. 2.46—North side and west end of Reynolds-Butler Building 31.2-a2 after planned test.
